# Bathymetric and Velocimetric Surveys at Highway Bridges Crossing the Missouri and Mississippi Rivers on the Periphery of Missouri, July–August 2018

By Richard J. Huizinga

Scientific Investigations Report 2020–5088

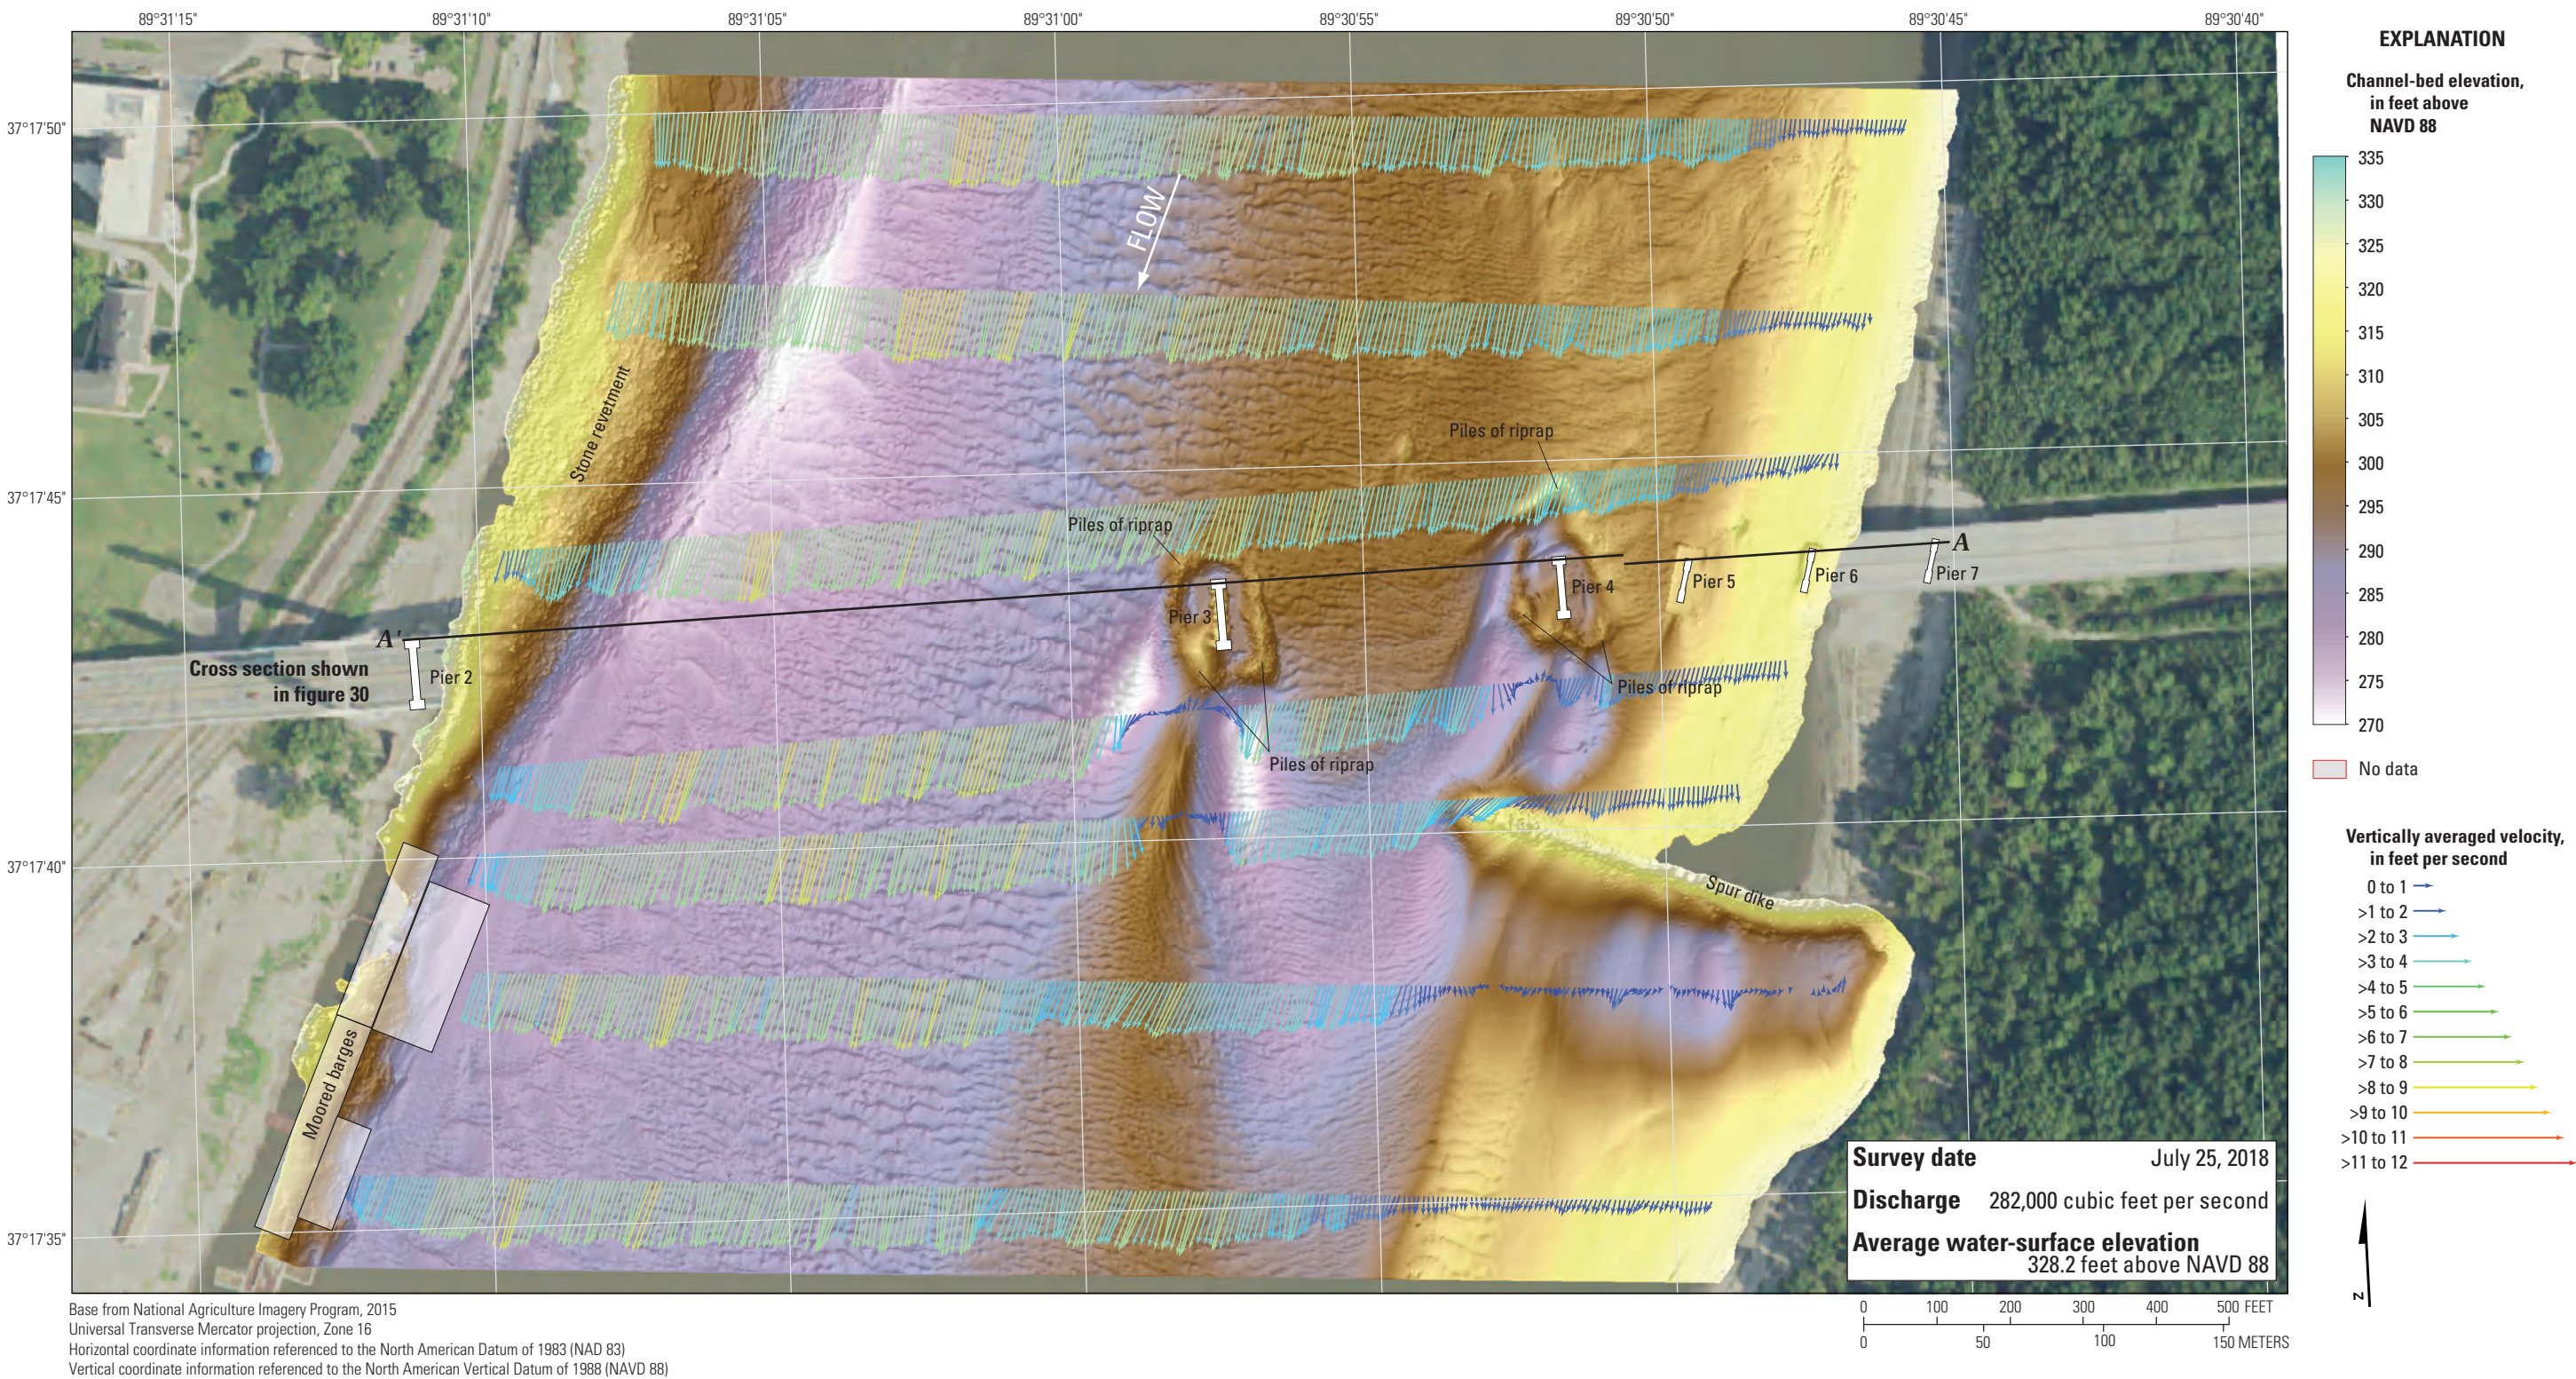
The vertically averaged velocity vectors indicate mostly uniform flow throughout the thalweg of the channel along the right bank, ranging from about 5 to 9 ft/s with minor variations in velocity across the sections (fig. 32). Moderate non-uniform flow was observed along the left side of the channel, particularly downstream from the spur dike on the left bank. Piers 3 and 4 were skewed to approach flow, causing substantial wake vortices with flow reversal and well-defined deposition ridges downstream (figs. 28, 32)

**Figure 32.** Bathymetry and vertically averaged velocities of the Mississippi River channel near structure A5076 on State Highway 34 at Cape Girardeau, Missouri.

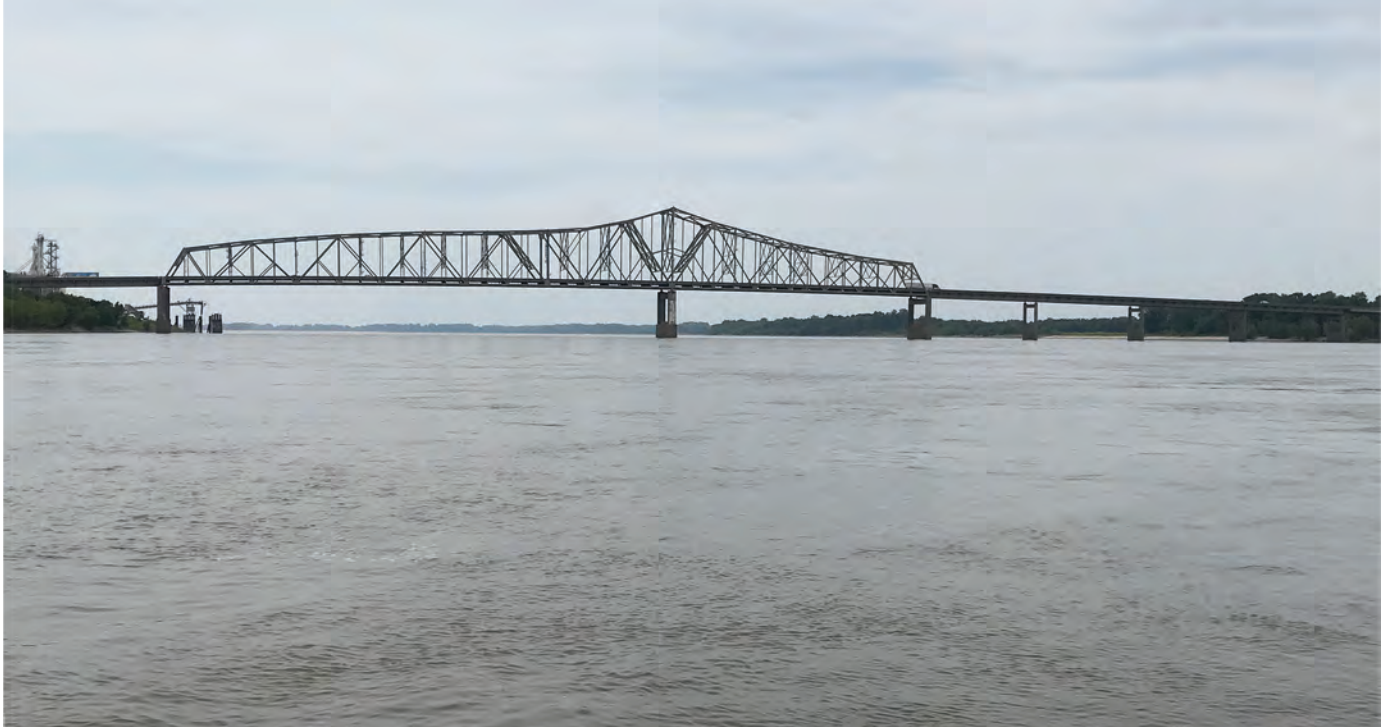
Structure A1700 on Interstate 155

The survey area was about 1,640 ft long and about 2,710 ft wide, extending across the active channel from the left (southeast) bank to the right (northwest) bank in the main channel (fig. 33). The upstream end of the survey area was about 675 ft upstream from the centerline of structure A1700, and bent 14 and piers 15 through 21 were in the water; however, bent 14 and pier 21 were in shallow water on the right and left banks, respectively, and bent 14 was not surveyed. The channel-bed elevations ranged from about 178 to 220 ft for most of the surveyed area (5 to 95 percentile range of the bathymetric data; table 3; fig. 34), except in areas of local scour on the right bank near the bridge and on the left bank near the downstream end of the reach (table 3; fig. 33). A few medium to large dunes were observed in the channel downstream from the bridge, as well as numerous small dunes and ripples throughout the channel (fig. 33).

into flow. The cross section along the upstream bridge face (fig. 35) shows a localized high bed elevation near the left edge of the riprap blanket at pier 20 that coincides with the observed object. Pier 15 is embedded in the stone revetment along the right bank (figs. 33, 35, 1.8E, 1.8F), and pier 16 seems to be surrounded by several almost random piles of riprap, which may help mitigate scour (figs. 33, 35, 1.8C, 1.8D).

Piers 18 through 20 of structure A1700 near Caruthersville, Mo. (site 38, fig. 1), were surrounded by riprap blankets (fig. 33) that were a minimum of 5 ft thick per the 1973 bridge plans (Missouri Department of Transportation, written commun., 2007; fig. 35). The blankets limited pier scour near piers 18 and 19 in all of the surveys, and prevented additional scour near pier 20 during the three later surveys at the site, including the substantial flood of 2011 (Huizinga, 2015). A scour hole was observed in material deposited on top of the blanket near pier 20 during the 2008 survey (fig. 35). The top surface of the blanket around pier 20 is very irregular (fig. 33), and seemed to have a depression adjacent to the pier that seems to penetrate the top of the blanket (fig. 35), which may have been the result of back-filling an existing scour hole or other low spot when the blanket was installed, per 1973 bridge plans (Missouri Department of Transportation, written commun., 2007). The random piles of riprap around the base of pier 16 (fig. 33) may help mitigate scour near that pier.

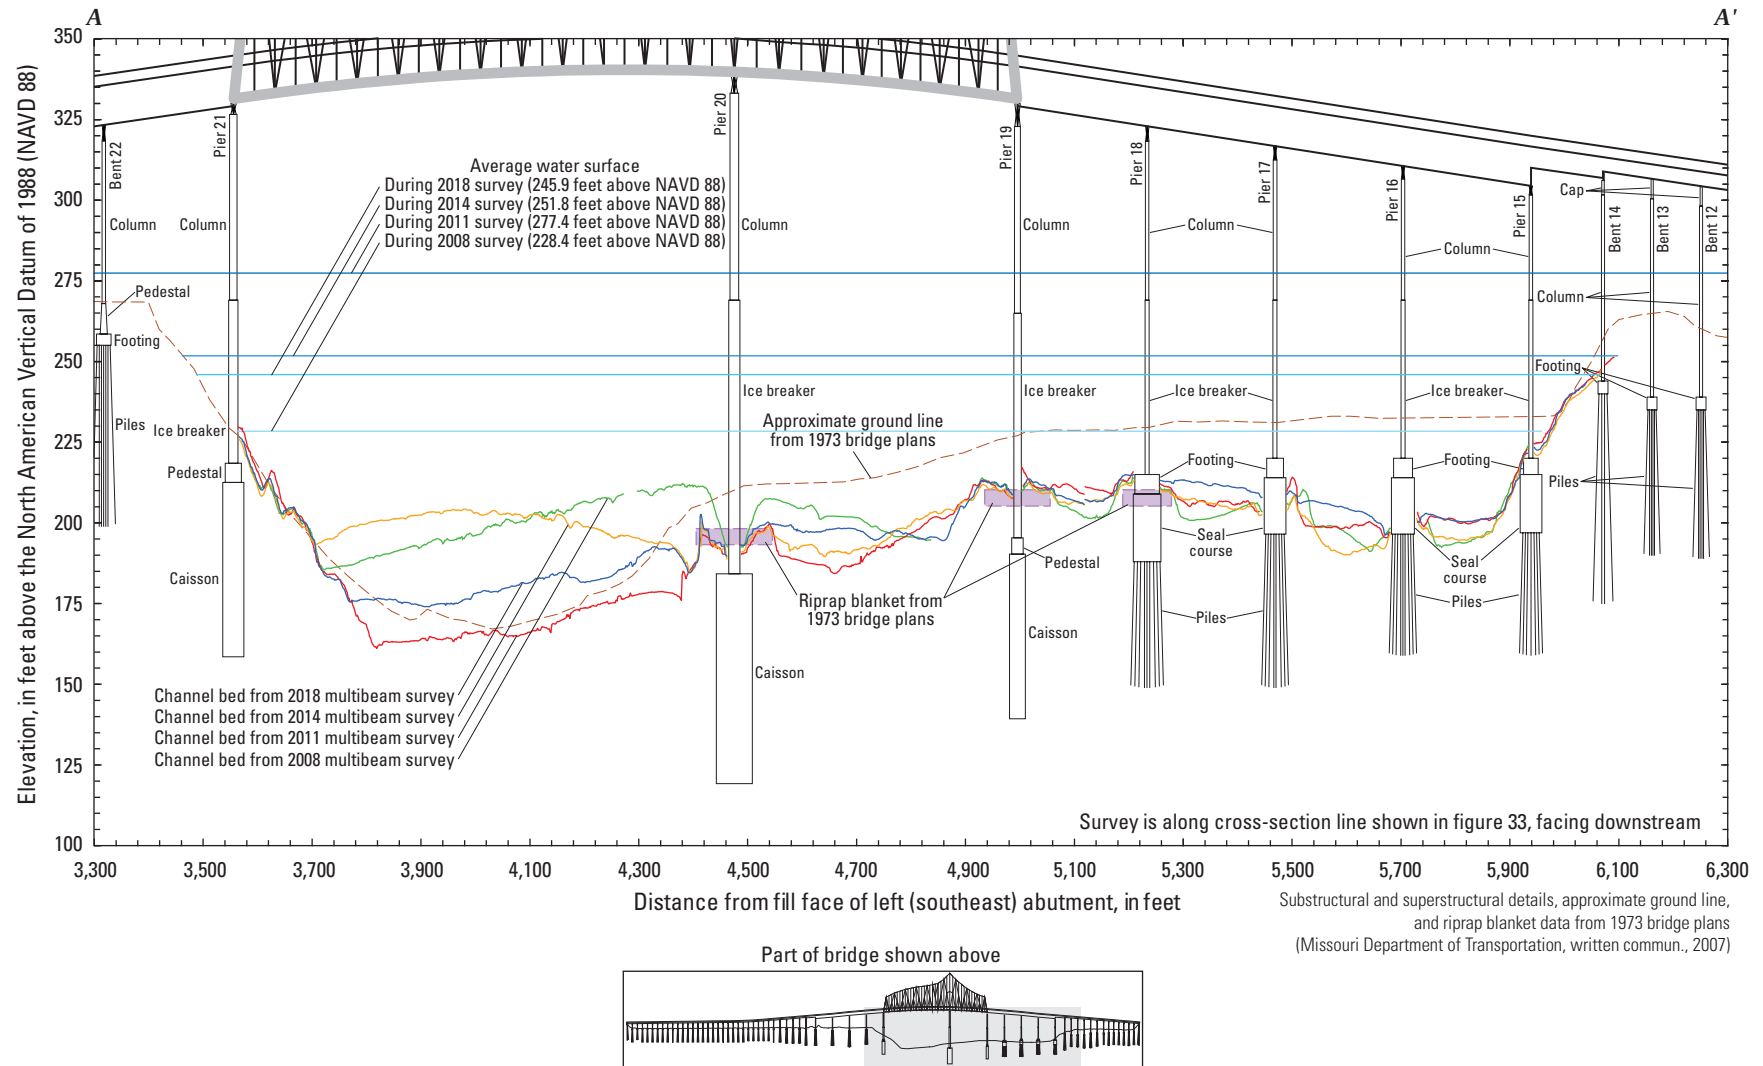
**Figure 35.** Key features, substructural and superstructural details, and surveyed channel bed of structure A1700 on Interstate 155 crossing the Mississippi River near Caruthersville, Missouri.

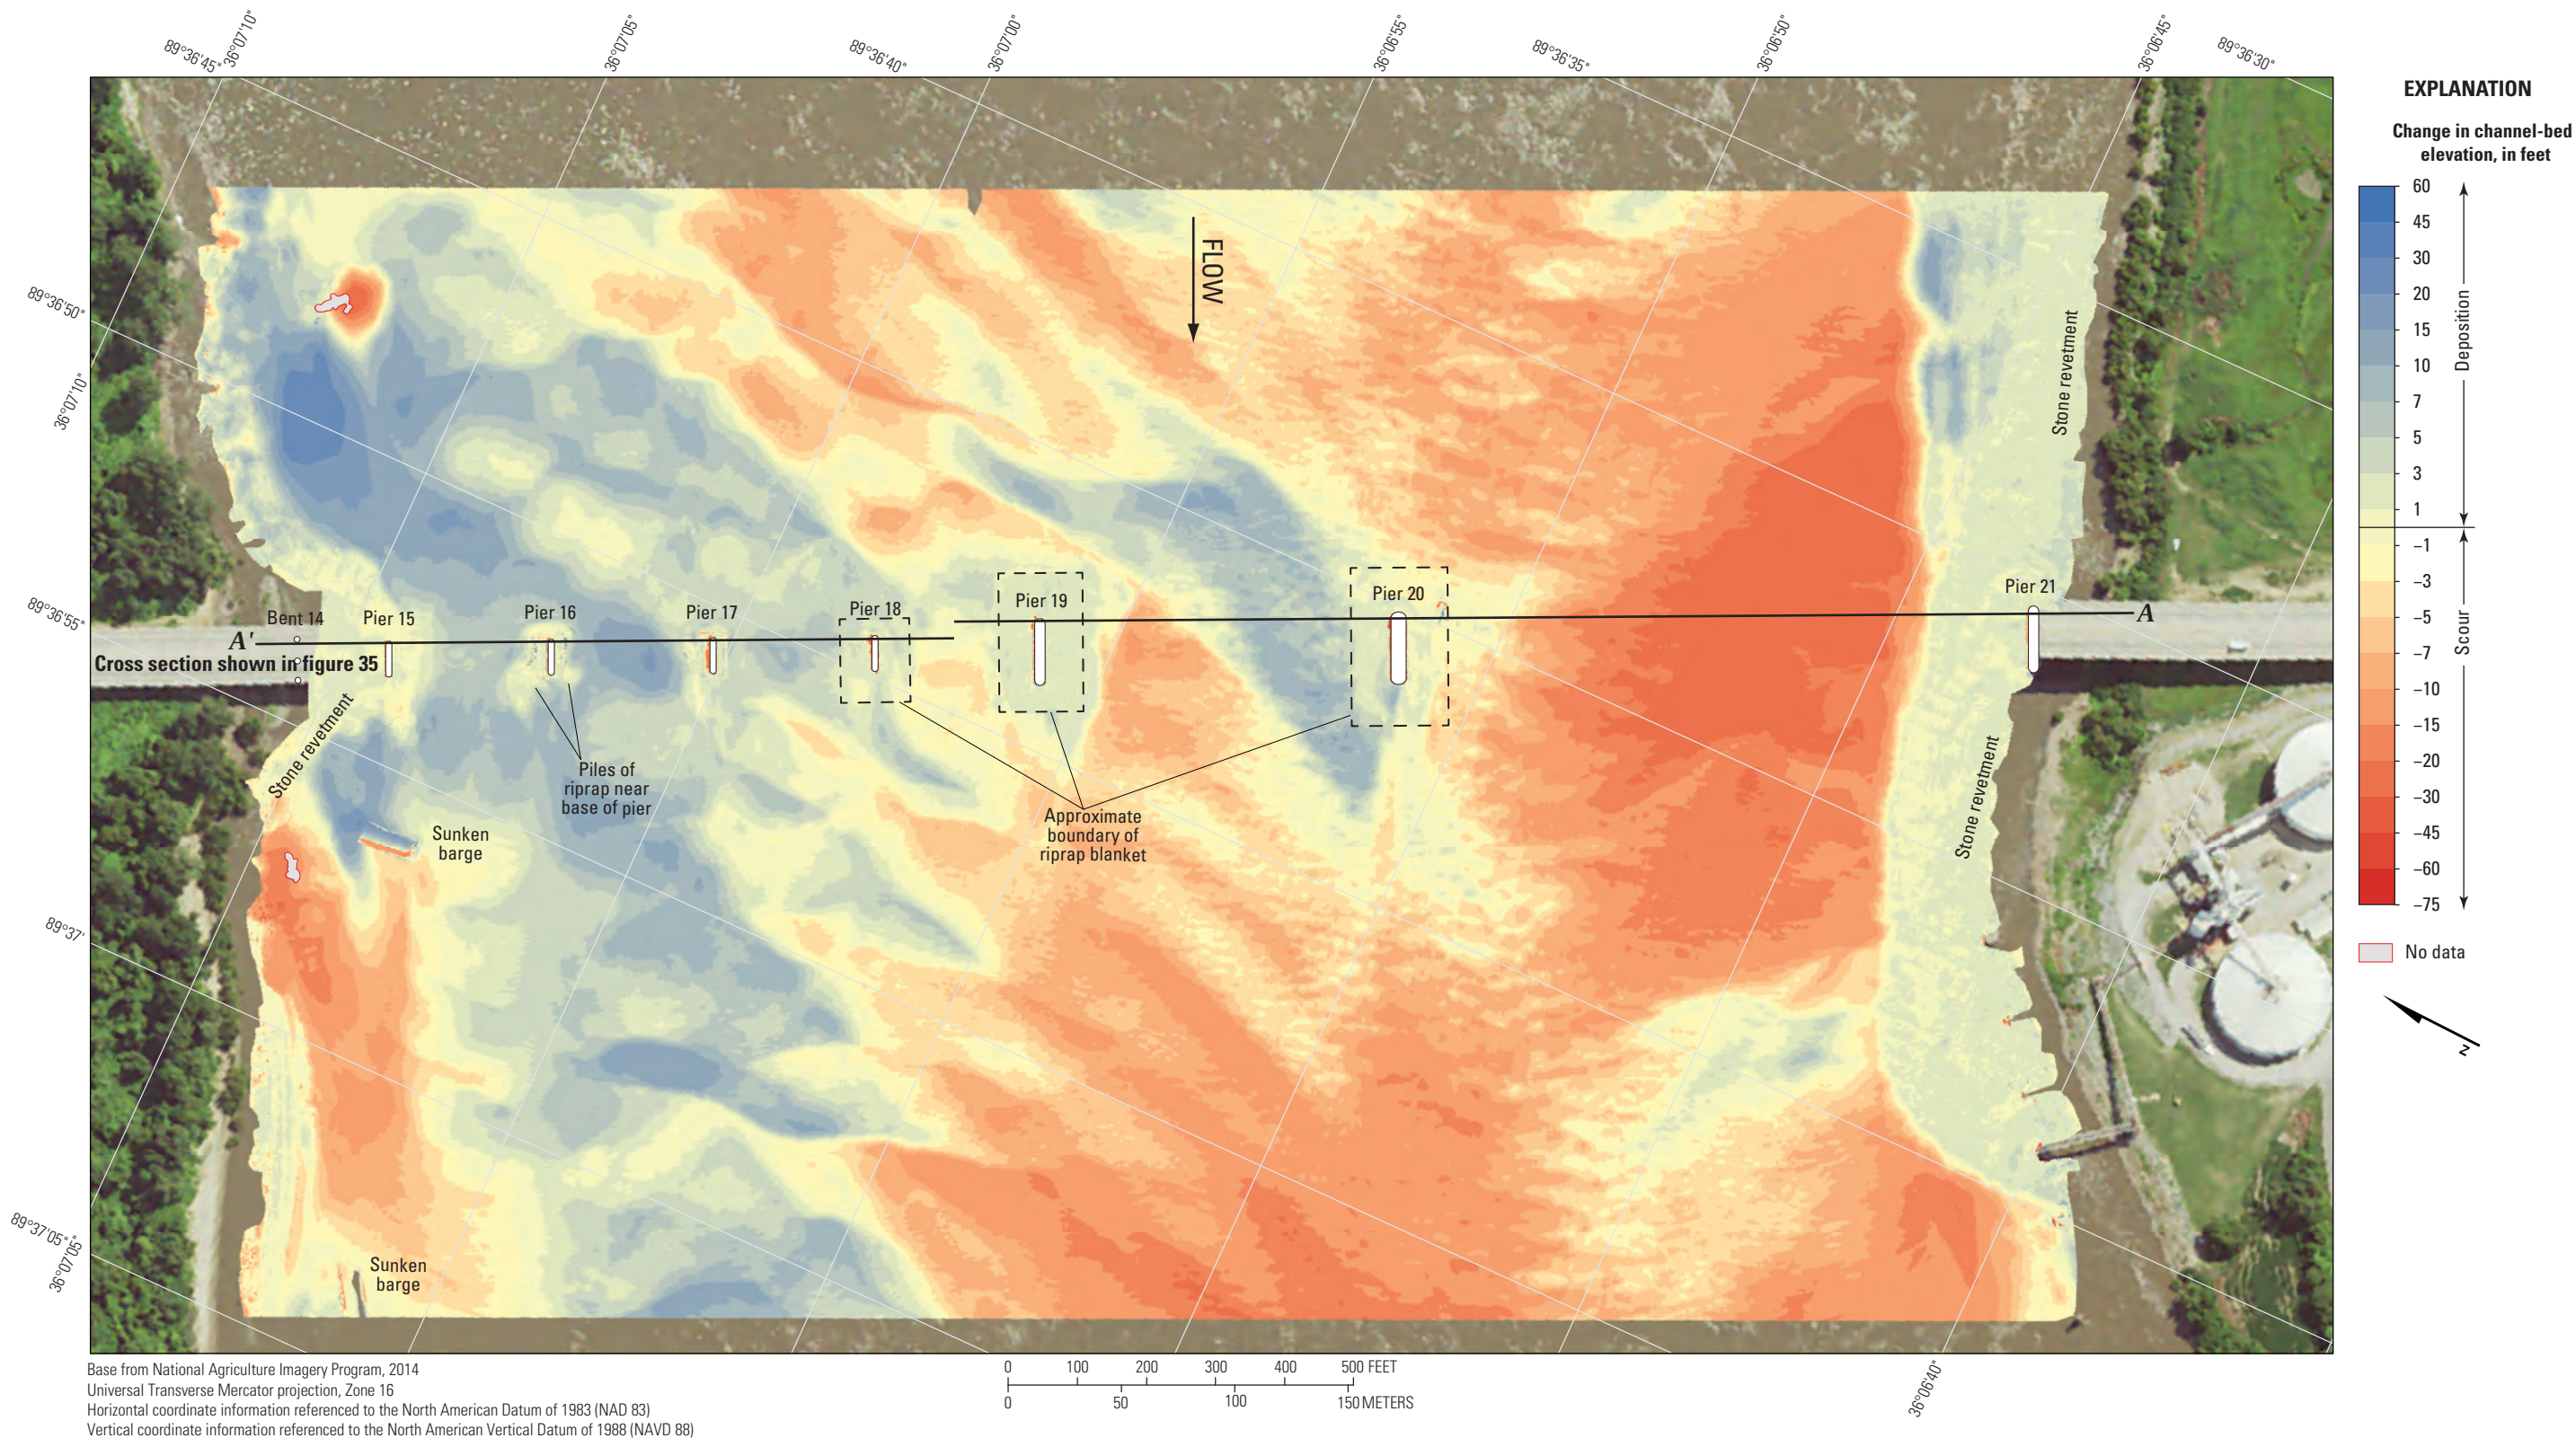
The difference between the survey on July 26, 2018, and the previous nonflood survey on June 11, 2014 (fig. 36), indicates more scour than deposition throughout the reach from 2014 to 2018, resulting in an average difference of  $-3.37$  ft between the bathymetric surfaces (table 8). The net volume of cut in the reach from 2014 to 2018 was about 800,000 yd<sup>3</sup>, and the net volume of fill was about 265,000 yd<sup>3</sup>, resulting in a net loss of about 535,000 yd<sup>3</sup> of sediment. Moderate to substantial scour of as much as 30 ft in the thalweg on the left (south) side is balanced with localized deposition of as much as 20 ft on the right (north) side of the channel, but the area of scour is more wide-spread than the deposition (fig. 36). A pile of rocks present upstream from the bridge near the right (north) bank in 2014 (see fig. 26 in Huizinga, 2015) was removed sometime after the 2014 survey, resulting in additional localized apparent scour there (fig. 36). Localized deposition along the toe of the left (south) bank upstream from the bridge implies additional stone revetment may have been placed there (fig. 36). The frequency distribution for 2018 has a higher percentage of grid cells between 176 and 190 ft than 2014, and a lower percentage between 194 and 204 ft (fig. 34). The cumulative percentage curve is between the 2011 and 2014/2008 curves below about 200 ft elevation (fig. 34).

**Figure 36.** Difference between surfaces created from bathymetric surveys of the Mississippi River channel near structure A1700 on Interstate 155 near Caruthersville, Missouri, on July 26, 2018, and June 11, 2014.

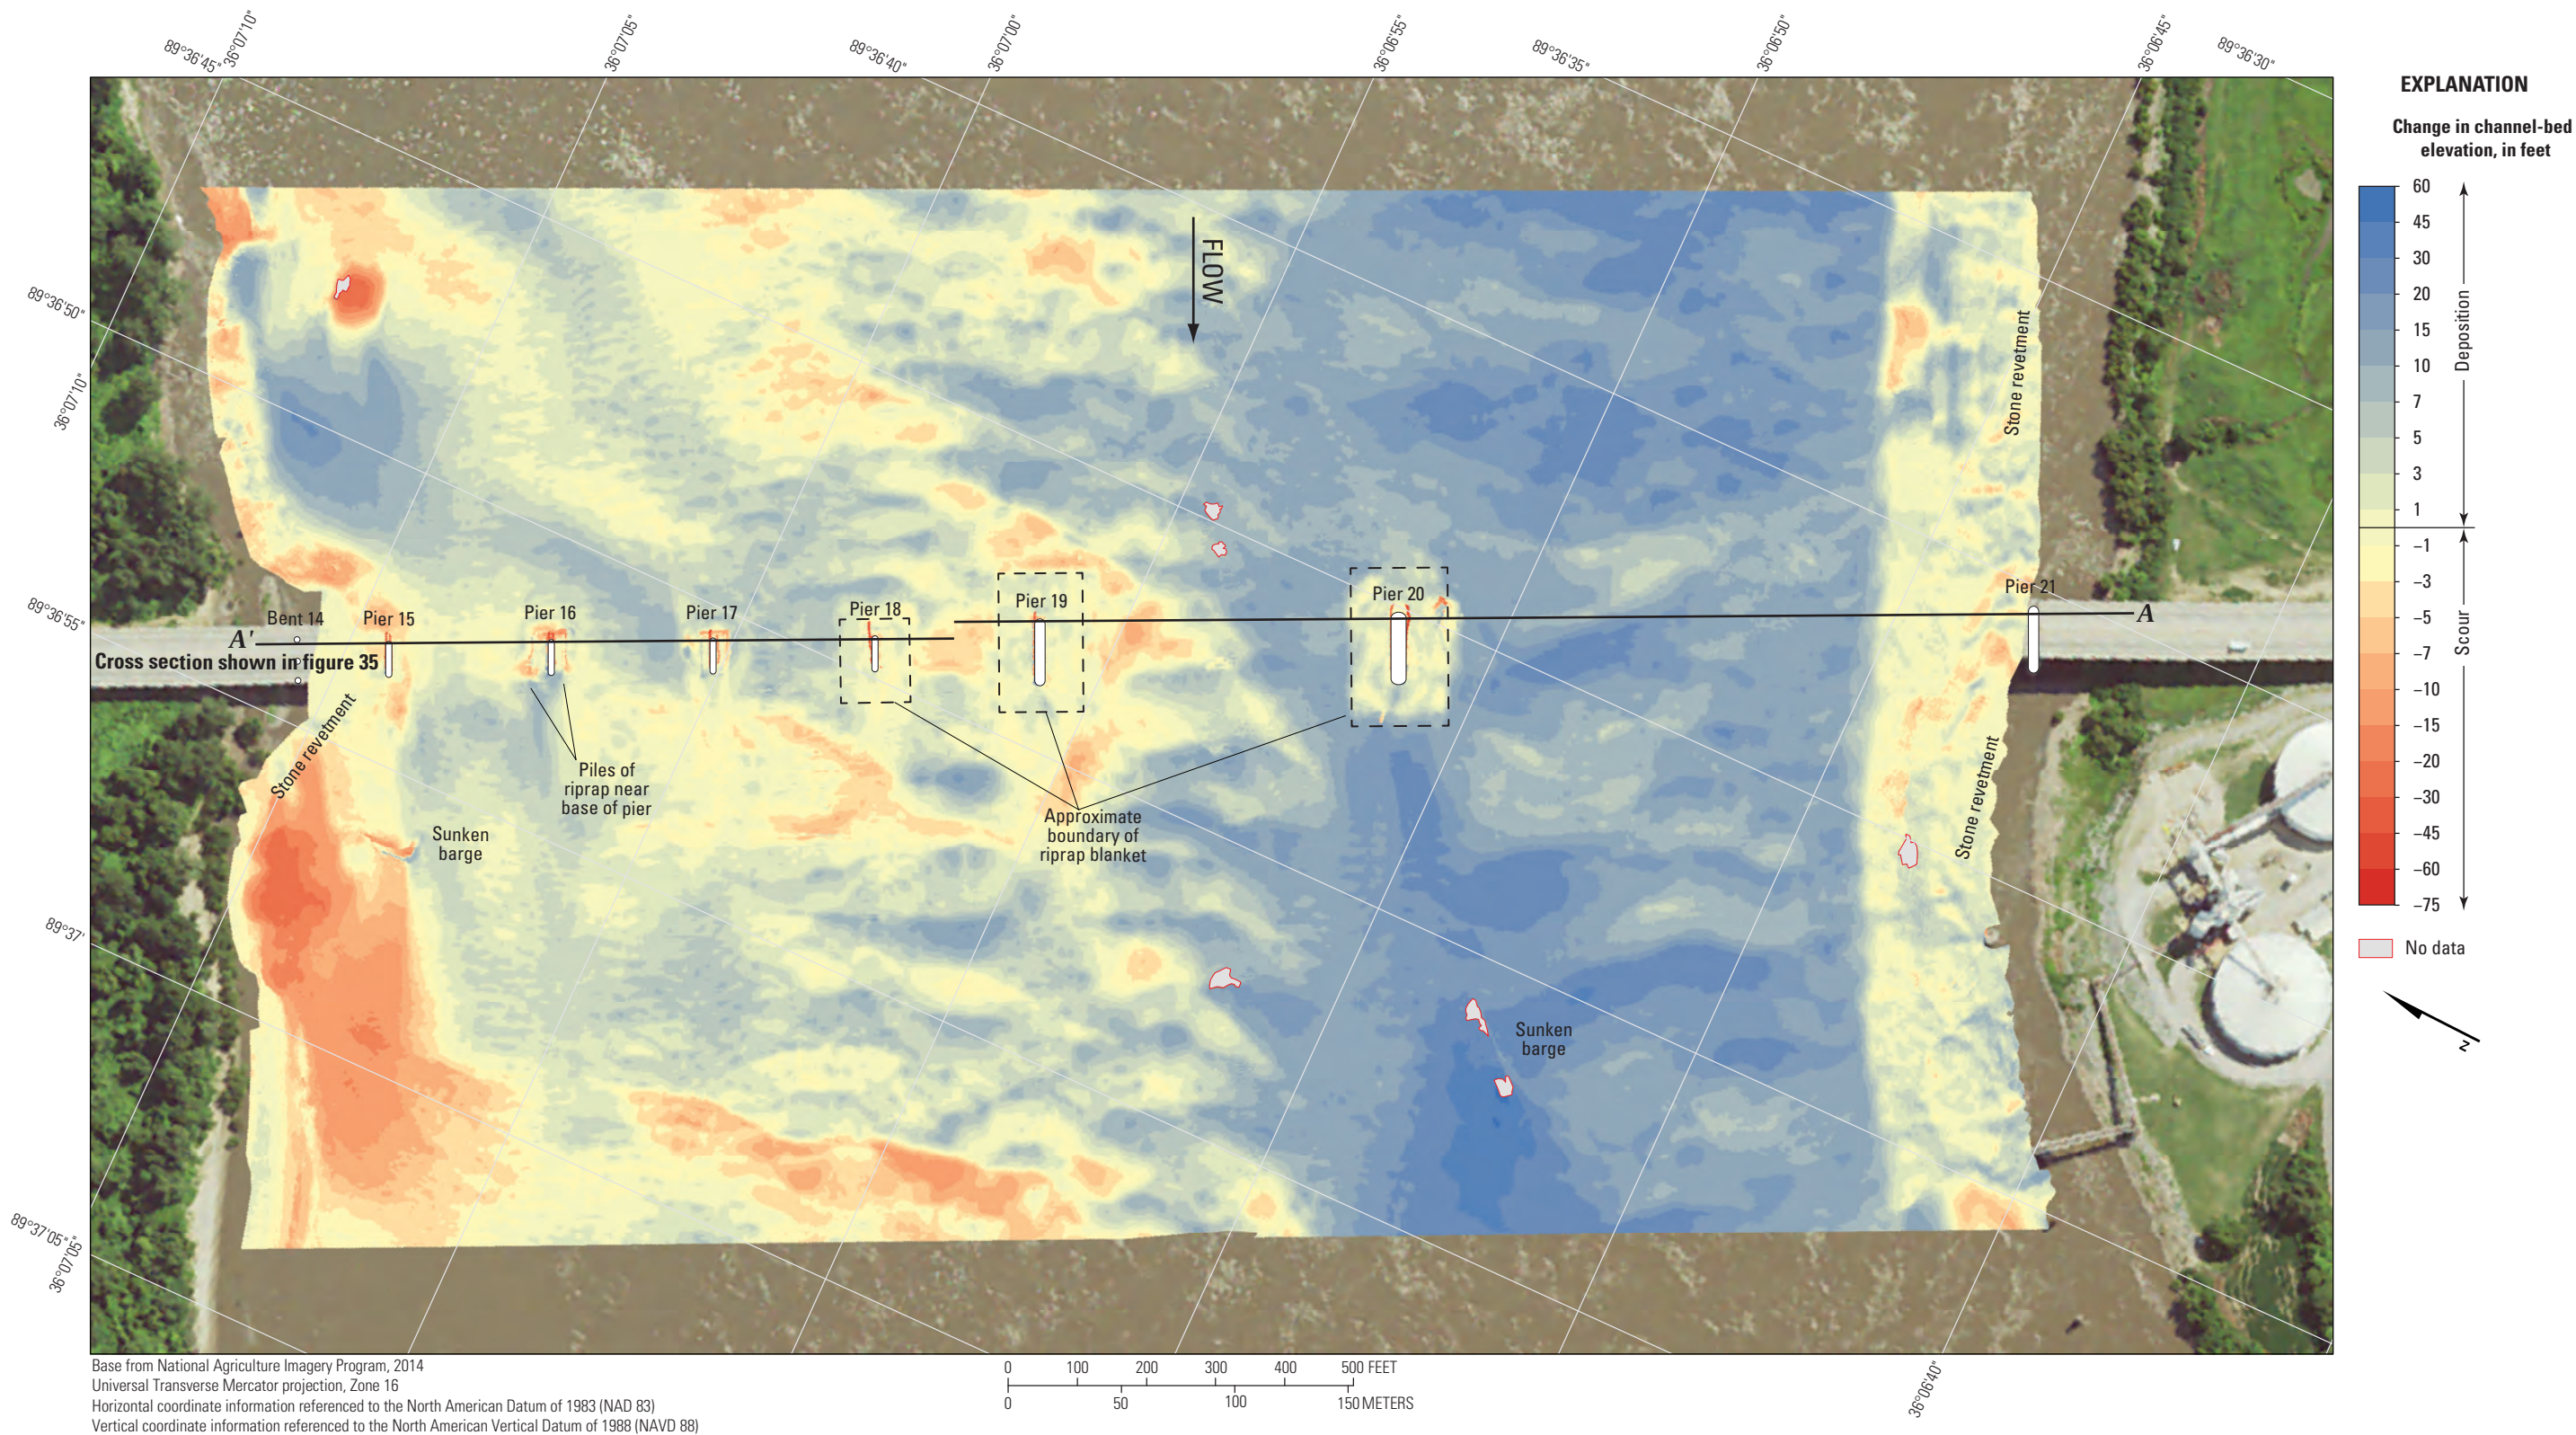
The difference between the survey on July 26, 2018, and the flood survey on May 5, 2011 (fig. 37), indicates substantial deposition of as much as 30 ft in the thalweg along the left

(south) side of the channel from 2011 to 2018, resulting in an average difference of  $+5.83$  ft between the bathymetric surfaces (table 8). The net volume of cut in the reach from 2011 to 2018 was about 121,000 yd<sup>3</sup>, and the net volume of fill was about 965,000 yd<sup>3</sup>, resulting in a net gain of about 844,000 yd<sup>3</sup> of sediment. Very localized scour of as much as 20 ft occurred downstream from the protruding rock revetment on the right (north) bank at the bridge (fig. 37). The frequency distribution for 2018 has a higher percentage of grid cells between 176 and 190 ft than 2011, but the 2011 distribution extended substantially lower than 2018 (fig. 34). The frequency distributions and cumulative percentages for 2011 and 2018 are similar above 212 ft (fig. 34).

**Figure 37.** Difference between surfaces created from bathymetric surveys of the Mississippi River channel near structure A1700 on Interstate 155 near Caruthersville, Missouri, on July 26, 2018, and May 5, 2011.

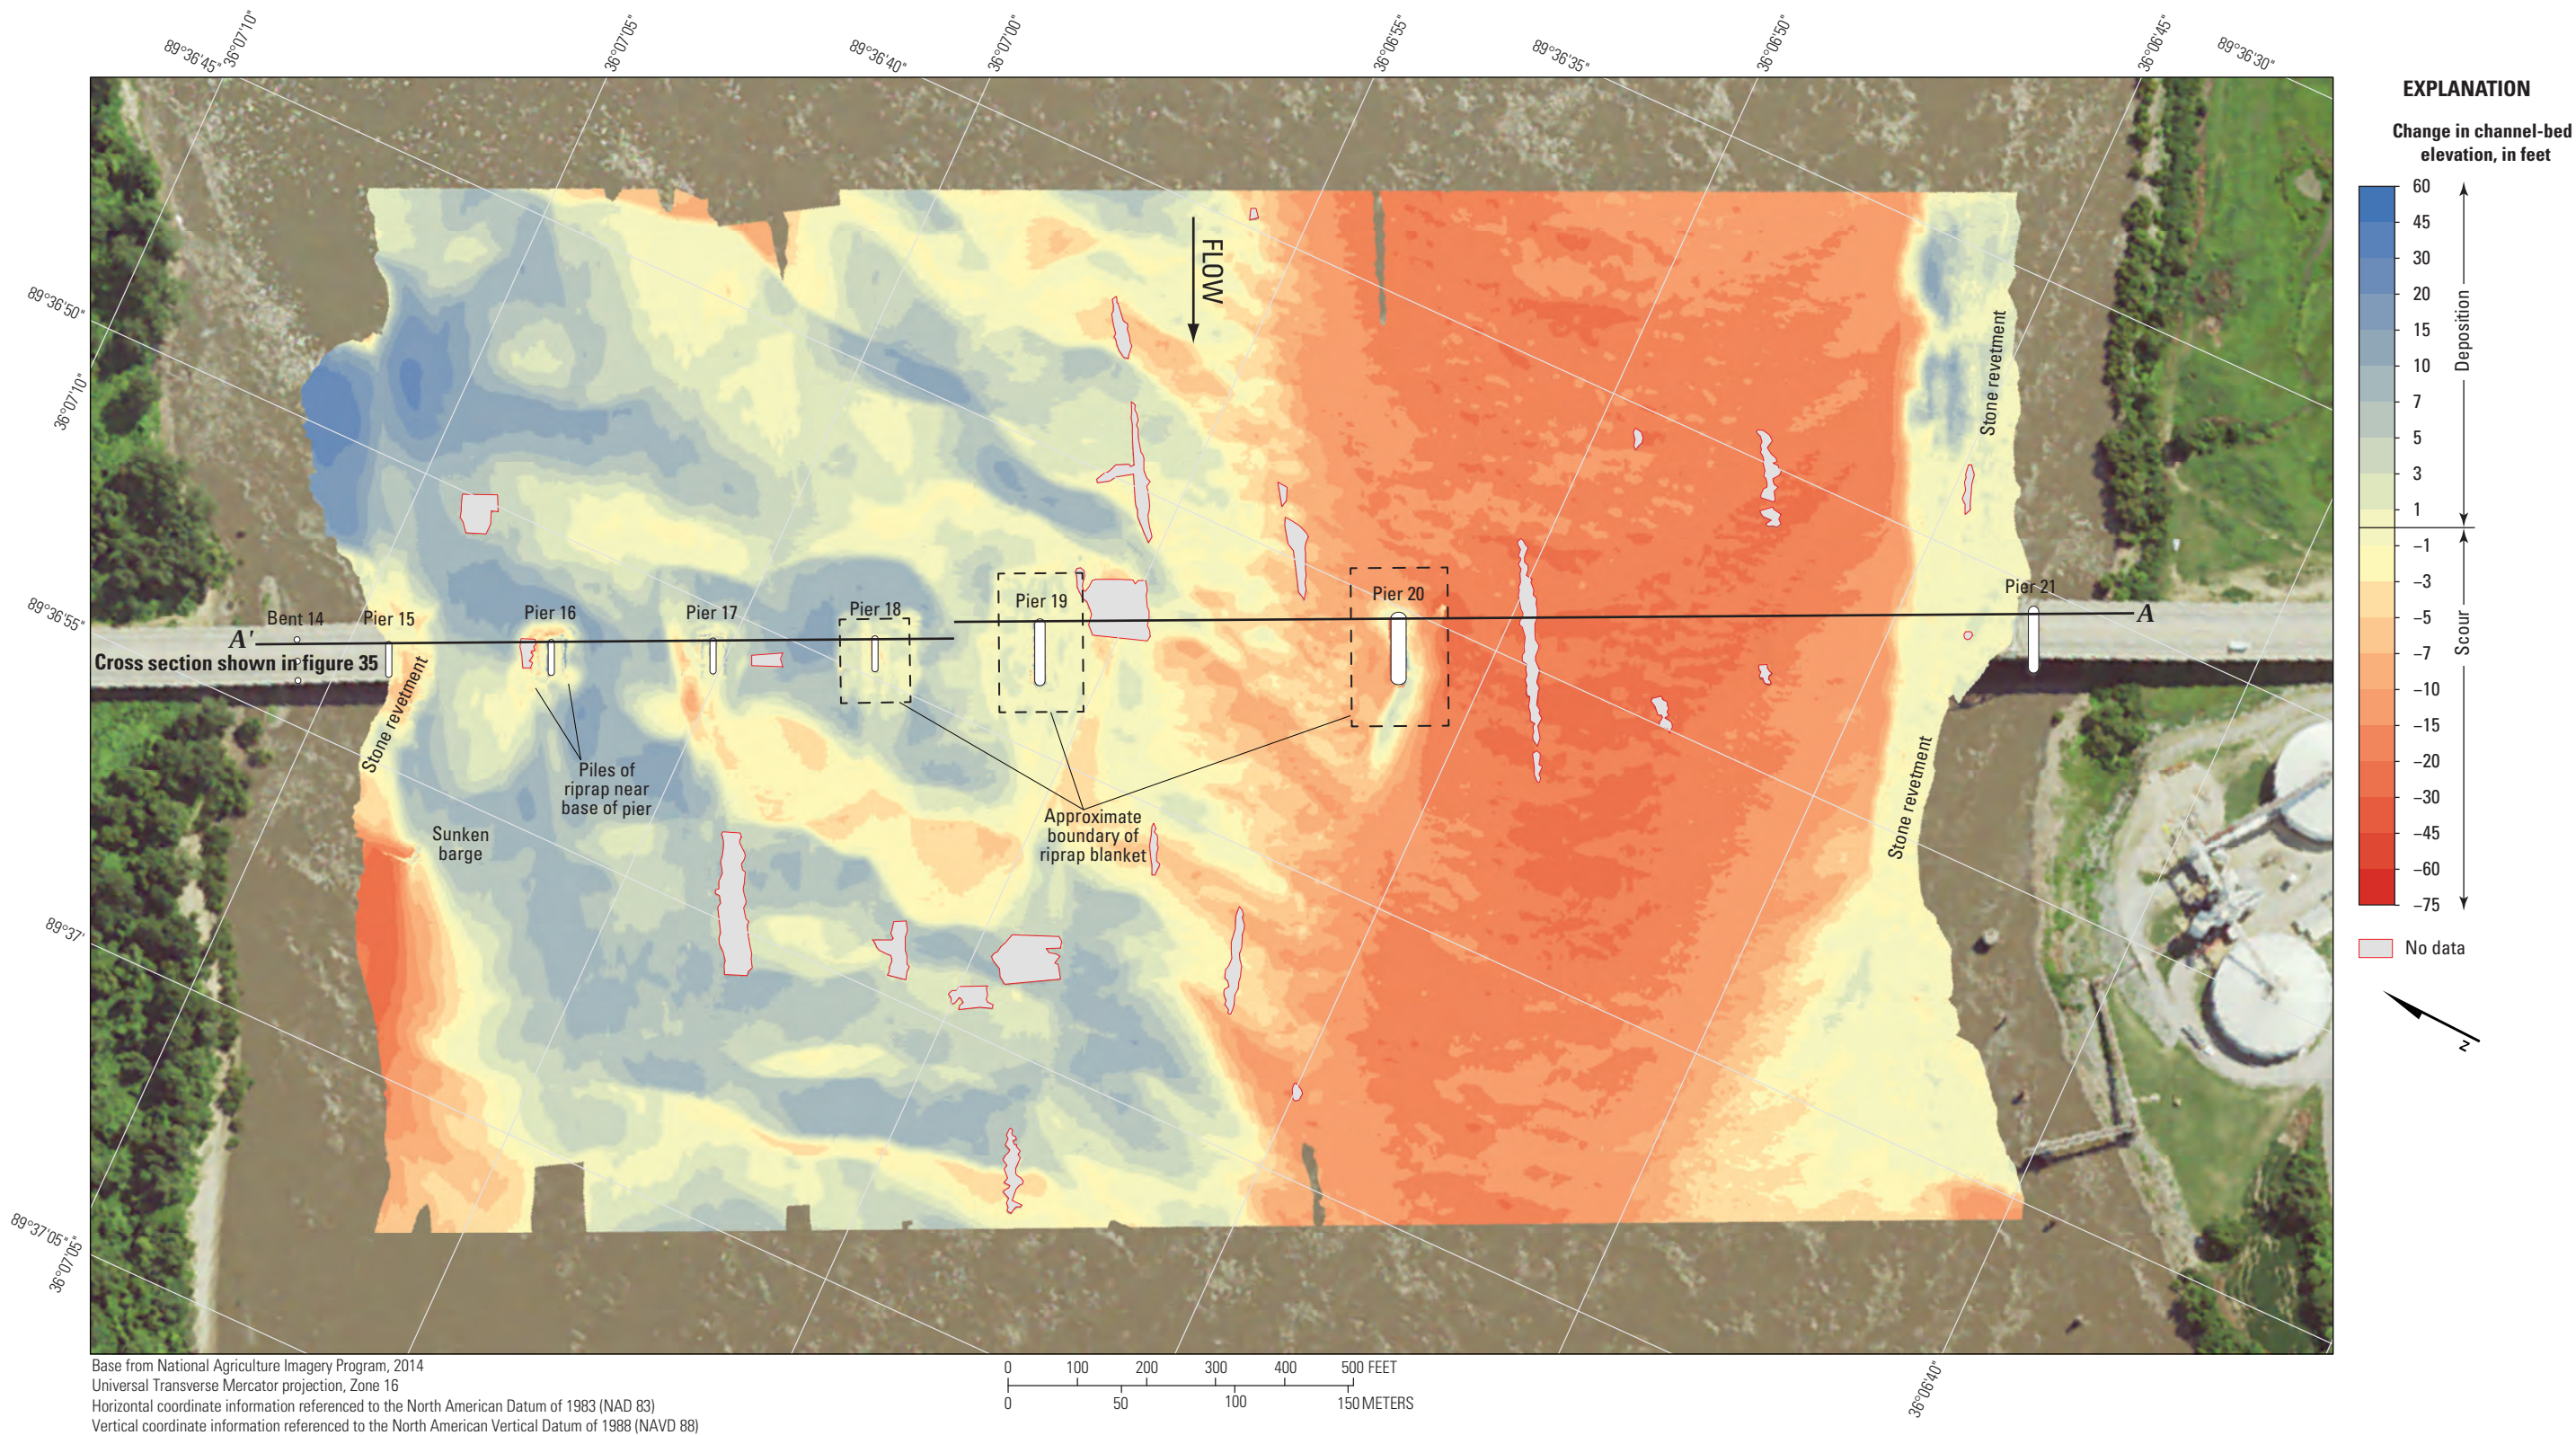
The difference between the survey on July 26, 2018, and the earliest survey on December 10, 2008 (fig. 38), indicates more scour than deposition throughout the reach from 2008 to 2018, resulting in an average difference of  $-3.98$  ft between the bathymetric surfaces (table 8). The net volume of cut in the reach from 2008 to 2018 was about 766,000 yd<sup>3</sup>, and the net volume of fill was about 255,000 yd<sup>3</sup>, resulting in a net loss of about 511,000 yd<sup>3</sup> of sediment. Moderate to substantial scour of as much as 30 ft in the thalweg on the left (south) side is balanced with localized deposition of as much as 20 ft on the right (north) side of the channel, but the area of scour is more widespread than the deposition (fig. 38). The frequency distribution for 2008 is similar to 2014, but does not extend as high up the banks because of the more limited surveyed area (fig. 34; table 8).

**Figure 38.** Difference between surfaces created from bathymetric surveys of the Mississippi River channel near structure A1700 on Interstate 155 near Caruthersville, Missouri, on July 26, 2018, and December 10, 2008.

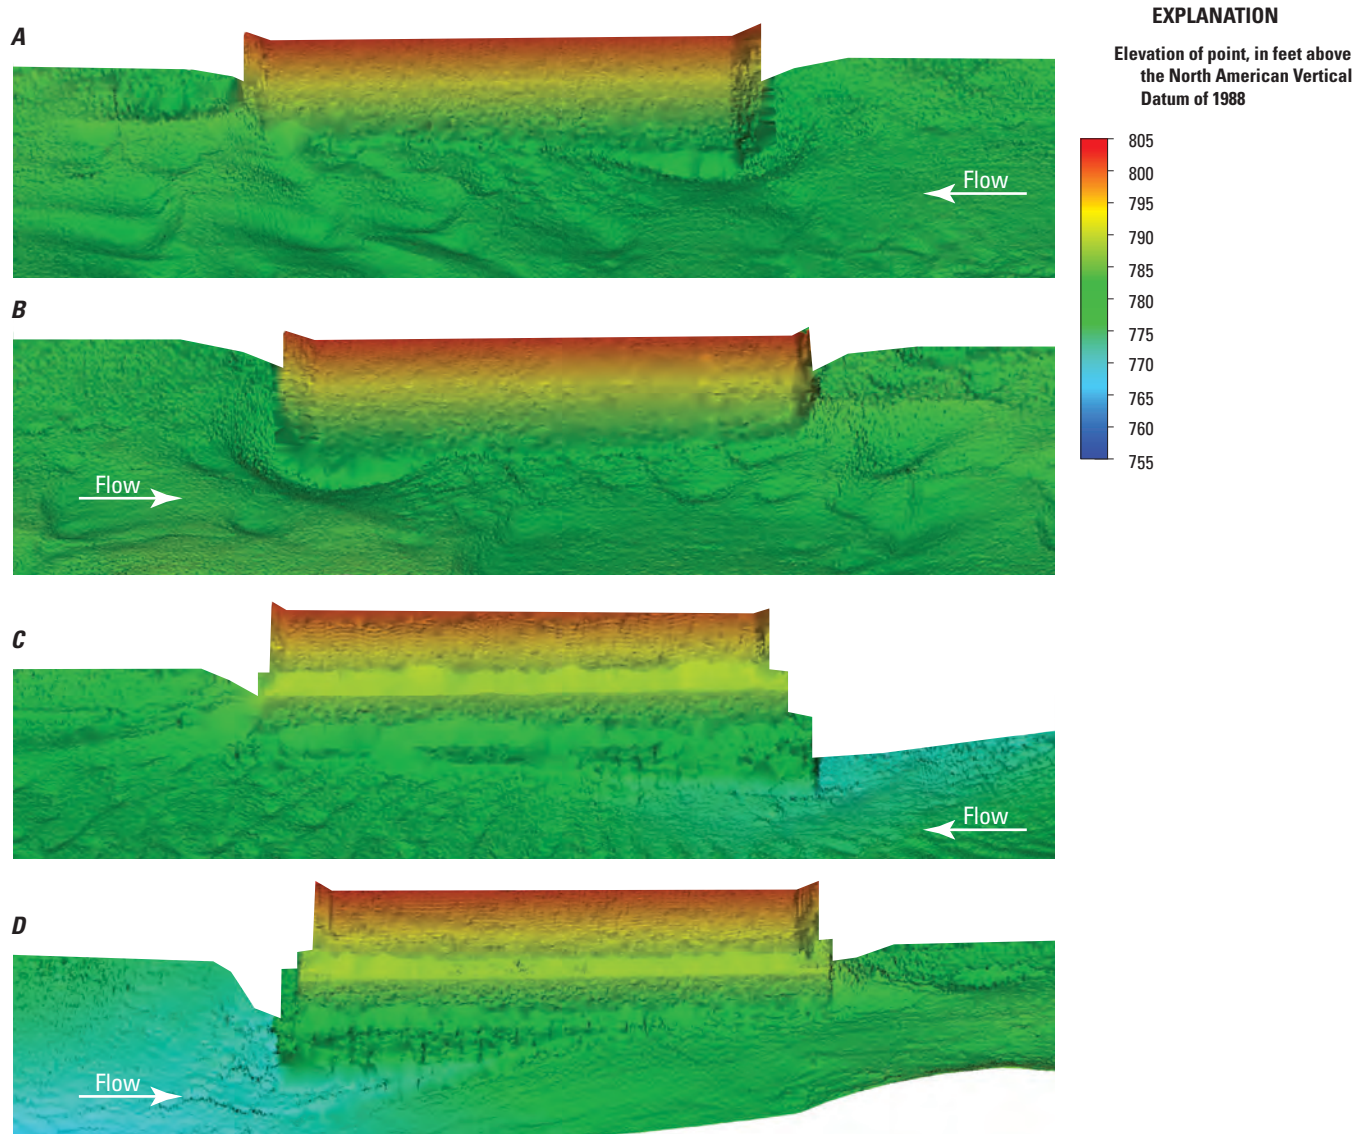
The minor scour hole near pier 10 was difficult to discern from nearby dunes and ripples (figs. 12, 1.2A, 1.2B), but had a minimum channel-bed elevation of about 777 ft (table 7). The top of the footing of pier 9 was evident on the upstream and left (east) sides, primarily because of the scour hole from the upstream spur dike (figs. 12, 1.2C, 1.2D). Information from bridge plans indicates that piers 9 and 10 are founded on shafts drilled into bedrock, with about 24 ft of bed material between the bottom of the scour hole and bedrock at the upstream face of pier 9 (table 7). The surveyed bed was generally similar to the multibeam survey on July 14, 2011, except on the left side of pier 10 (fig. 14).

**Figure 1.2.** Shaded triangulated irregular network visualization of the channel bed and main channel piers of dual bridge structure A3664 on U.S. Highway 36 over the Missouri River at St. Joseph, Missouri. *A*, left (east) side of pier 10. *B*, right (west) side of pier 10. *C*, left (east) side of pier 9. *D*, right (west) side of pier 9.
